## **FIRE TEST REPORT EUI-21-000441**

According to BS EN 1363-1:2020 and BS EN 1365-1:2012

<b>Test</b>	REPORT EUI-21-000441
<b>Performed on</b>	8 <sup>th</sup> February 2022
<b>Regarding</b>	Loadbearing timber frame with K112 and K118 fire test material
<b>Sponsor</b>	KINGSPAN INSULATION LTD Torvale Industrial Estate Pembridge, Herefordshire HR6 9LA UNITED KINGDOM

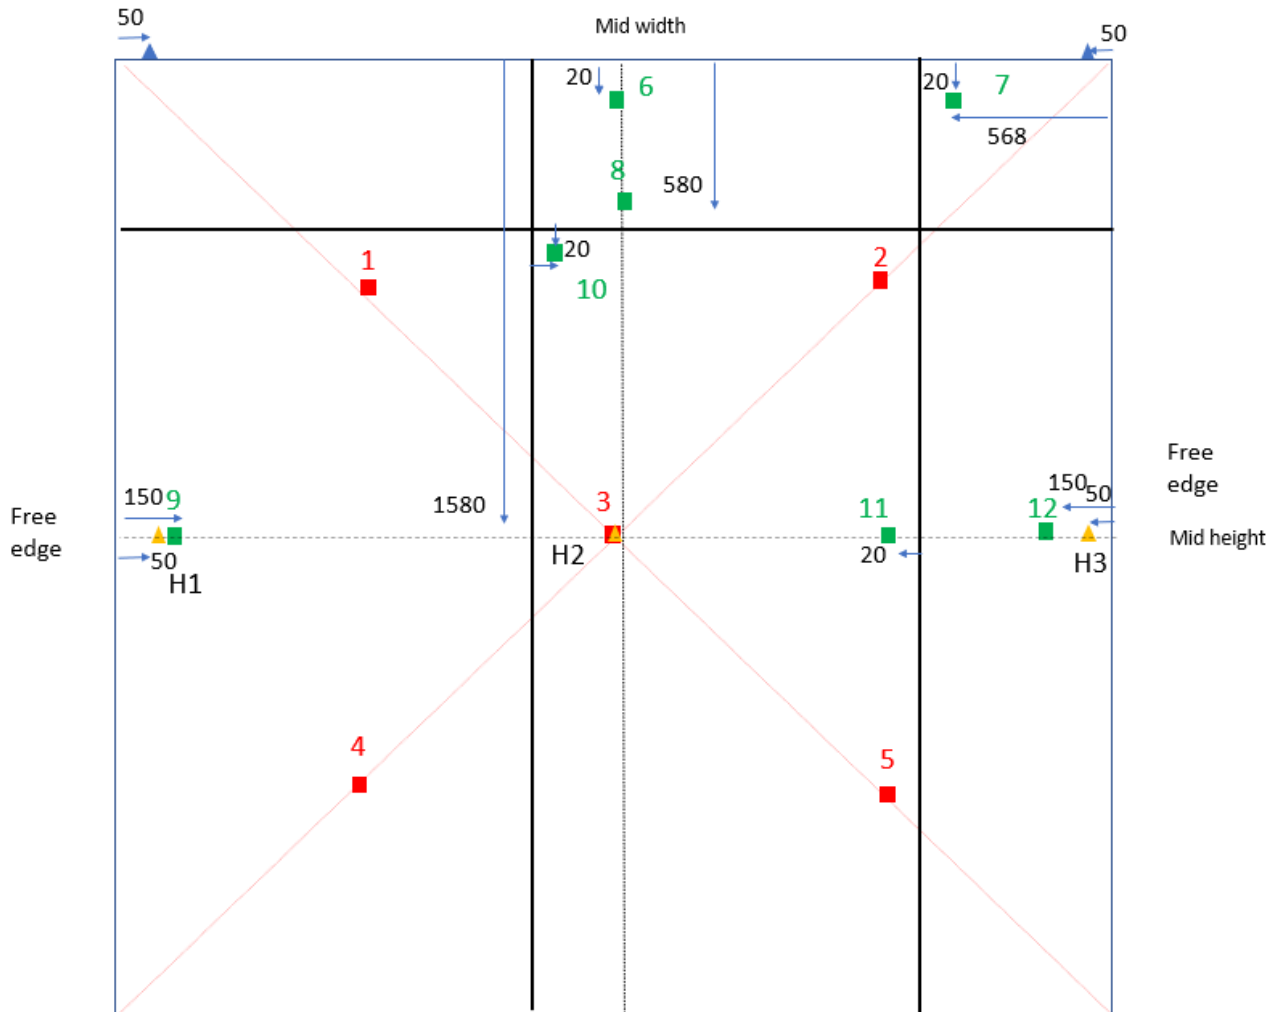
**APPENDIX B: INSTRUMENTATION**

- Thermocouples for average/maximum temperature rise (at least 50mm from hotspots)
- Thermocouples maximum temperature rise (at least 20mm from hotspots)
- ▲ Displacement gauges for horizontal deflection
- ▲ Displacement gauges for vertical deflection

See Diagram 1, Appendix B for the plot of the instrumentation, and Charts 5 and 6, Appendix C for the measurements recorded during the test.

<i>External thermocouples - Location</i>	<i>Markings</i>	<i>Appendix</i>
On the centre of the quadrant	1, 2, 4, 5	B
On the geometric centre of the specimen	3	
At the head of the sample, in line with a stud/ mullion	7	
At the head of the specimen, at mid-width	6	
At the junction of a stud and a rail	10	
At mid-width, adjacent to a horizontal joint	8	
At mid height, 150mm in from the edge	9, 12	
At mid-height, adjacent to a vertical joint	11

The deflection was measured using calibrated wire type displacement gauges and recorded via a data acquisition system. The vertical deflection was measured using two gauges at the top left and top right corners, 50 mm from the edge of the sample. The horizontal deflection was measured at mid-height, 50 mm from the edges of the sample and at its geometric centre.

Location	Markings	Appendix
Vertical deflection – 50 mm from the edge of the sample	1 (left), 2 (right)	B
Horizontal deflection – 50 mm from the edge of the sample	3 (left), 5 (right)	
Horizontal deflection – centre of the sample	4

See Diagram 1, Appendix B for the plot of the instrumentation and Charts 7 to 9 for the measurements recorded during the test.

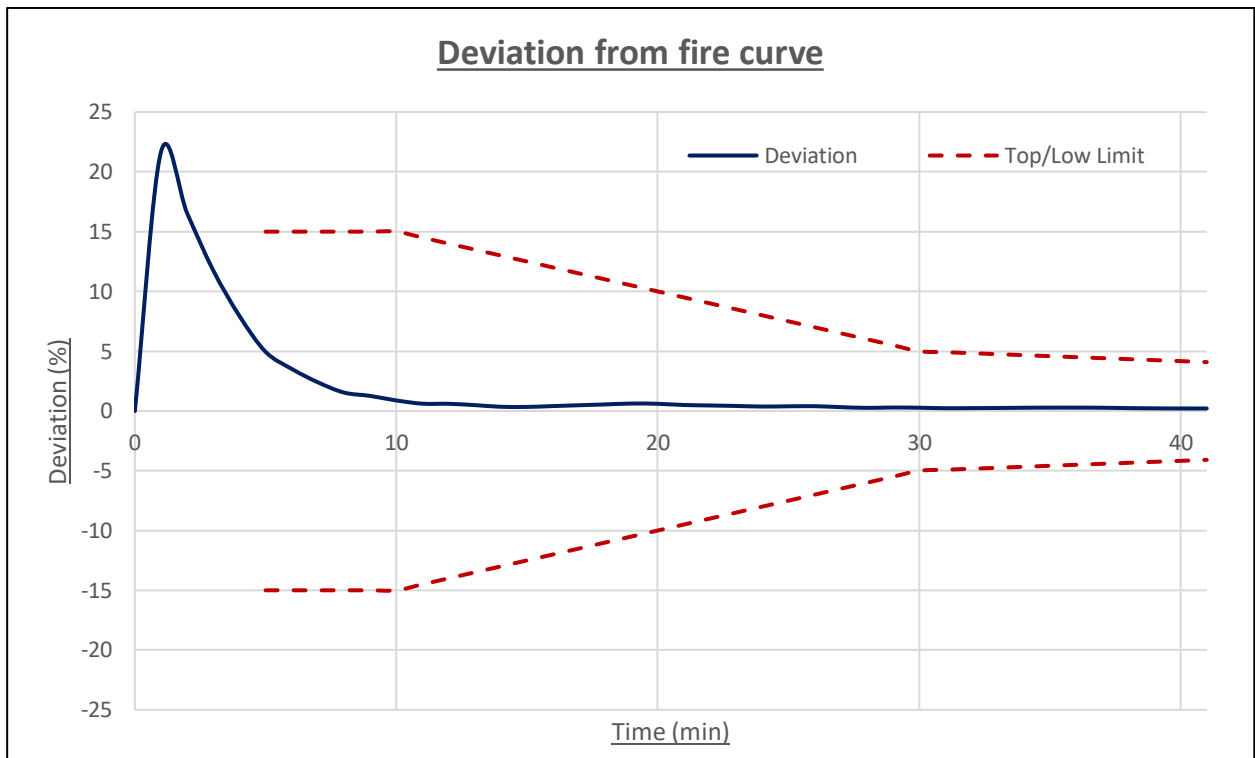
Chart 3 – Deviation of the average furnace temperature from the standard thermal curve

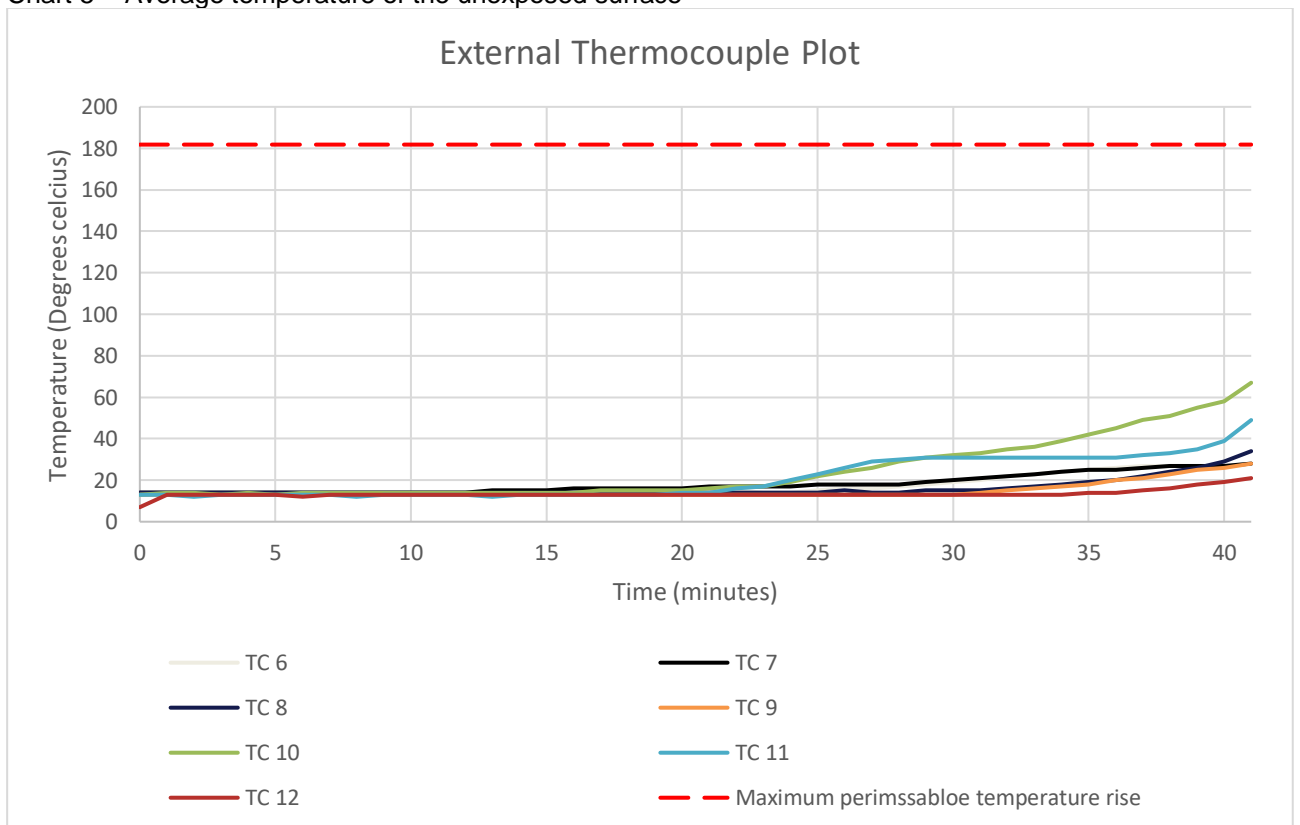
Chart 6 – Maximum temperature rise of the unexposed side

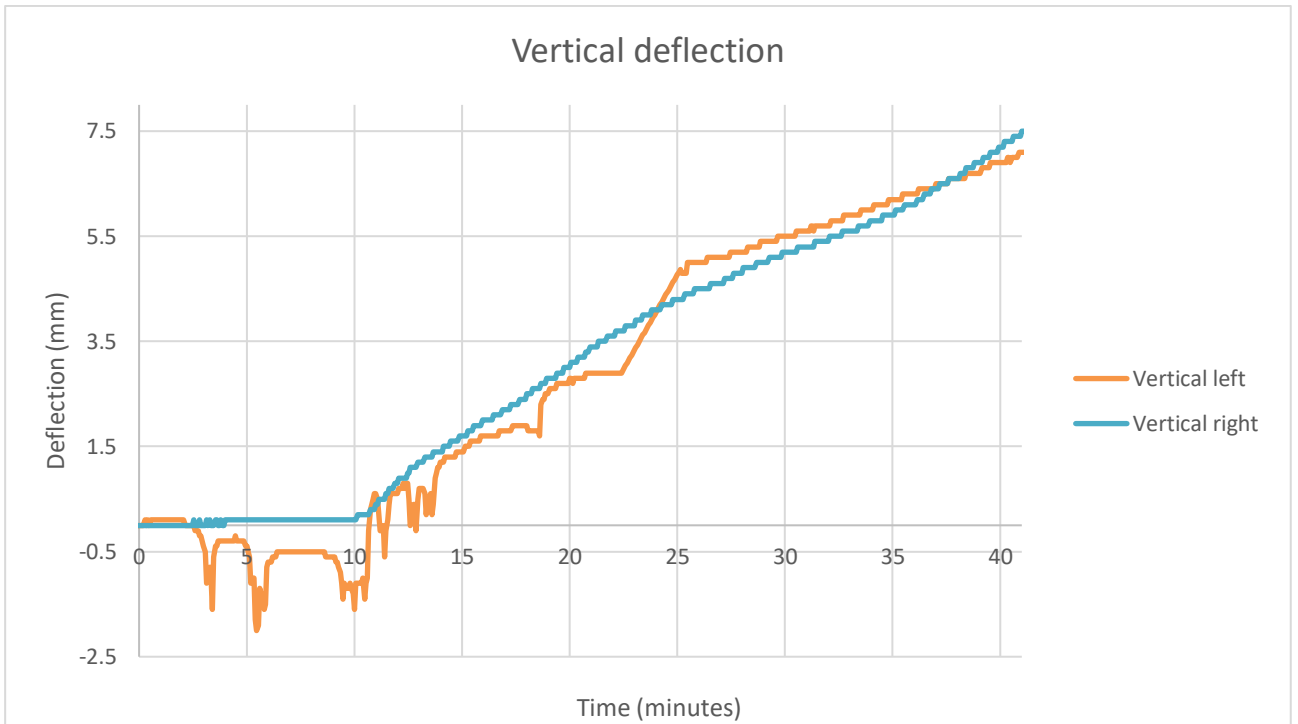
Chart 7 – Vertical deflection measurements of the LVDTs

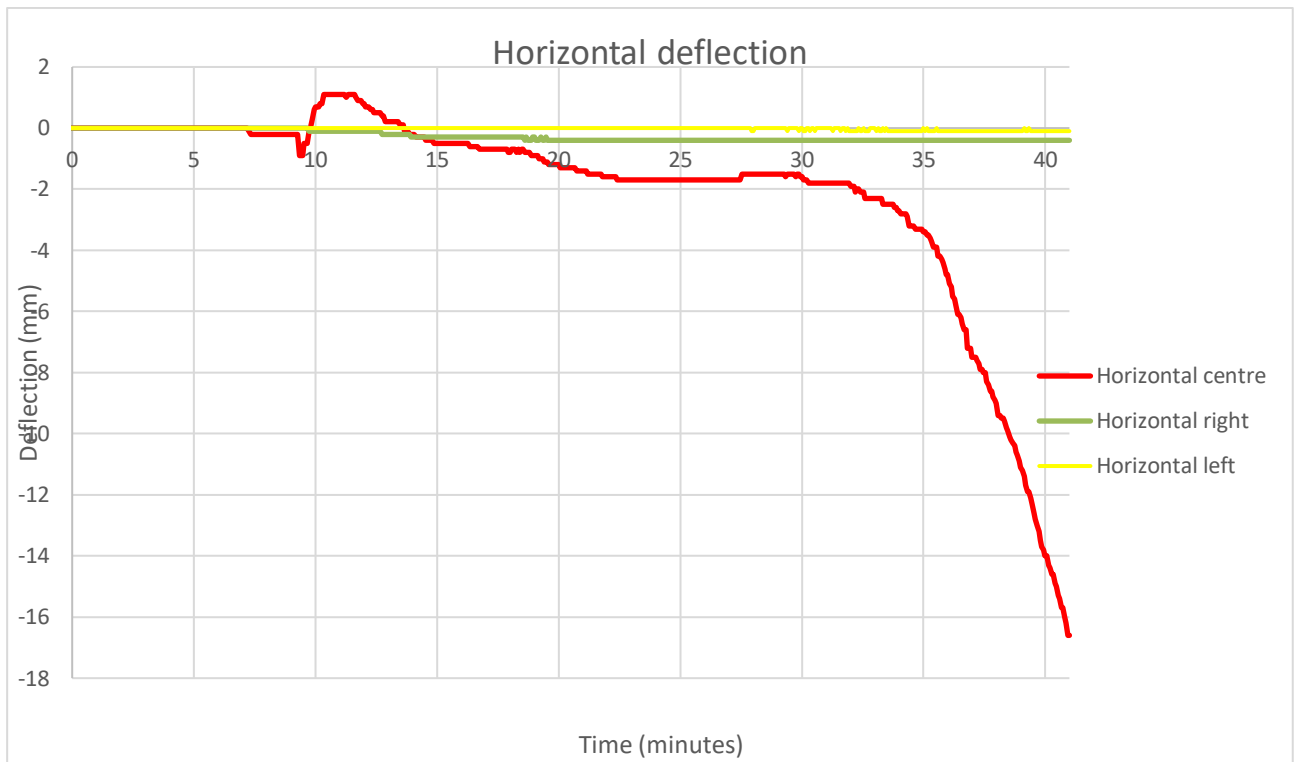
Chart 9 – Horizontal deflection measurements

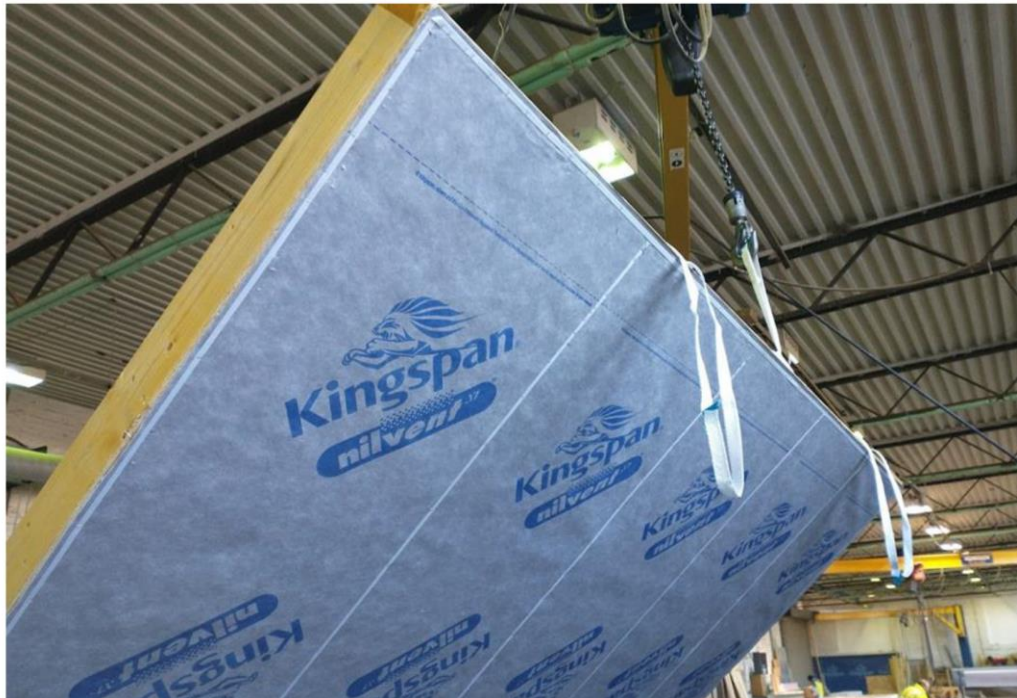
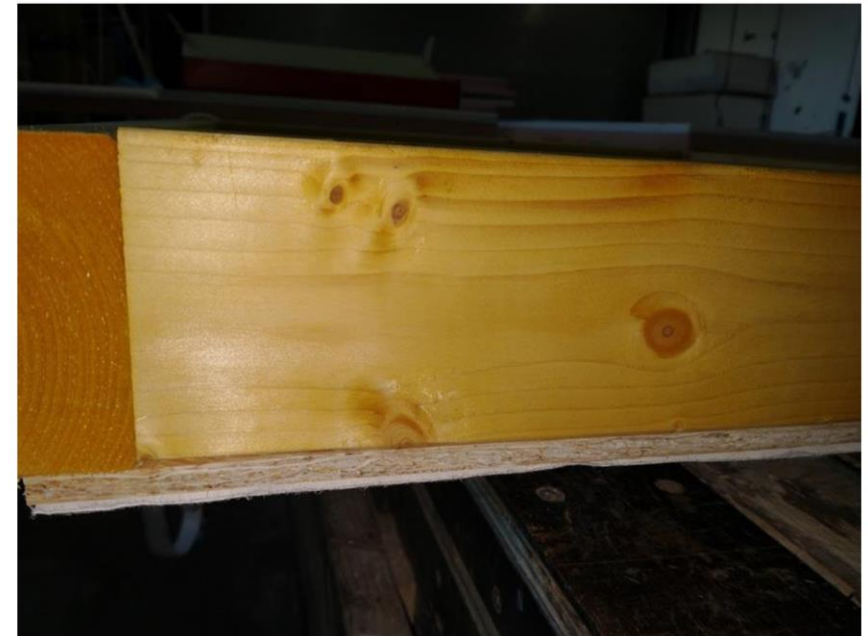
- Timber frame assembled complete with OSB and Nilvent Breather Membrane

Photograph 1 – View of the construction of the timber frame

- A perimeter frame reference perimeter frame (Kingspan Insulation Limited), with section 89 x 38 mm, C16 grade softwood and stated density 370 kg/m<sup>3</sup>. The perimeter frame consisted of 6 vertical studs, 2924mm in length. Horizontal noggins were included at 600mm from the top of the sample. Please see Appendix A, Drawing 1 for a view of the frame layout. The timber frame was butted with the head and bottom rails running the full width of the panel. The framework was secured with Montana D34GSC 3.1x88mm (DxL) screws, with two screws used per joint.

- One layer of face panel reference OSB facing (Kingspan Insulation Limited), fitted to one side of the frame, 9 mm thick. The OSB board was through fixed into the external timber framework with 2.8x50mm (D x L), FAWGS/SC2 (Montana) screws. The screws were spaced at 150mm centres to the perimeter sections of the external framework and 300mm centres to the intermediate framework

External breather membrane (Kingspan Nilvent), made of laminated 3-layer polyolefin, 1500mm high, overlapping 450mm and fixed with white tape and secured with 71 x 10 x 0.68mm V2A stapled at 300mm centres. This was secured to the OSB boarding layer, as shown in Photograph 9.

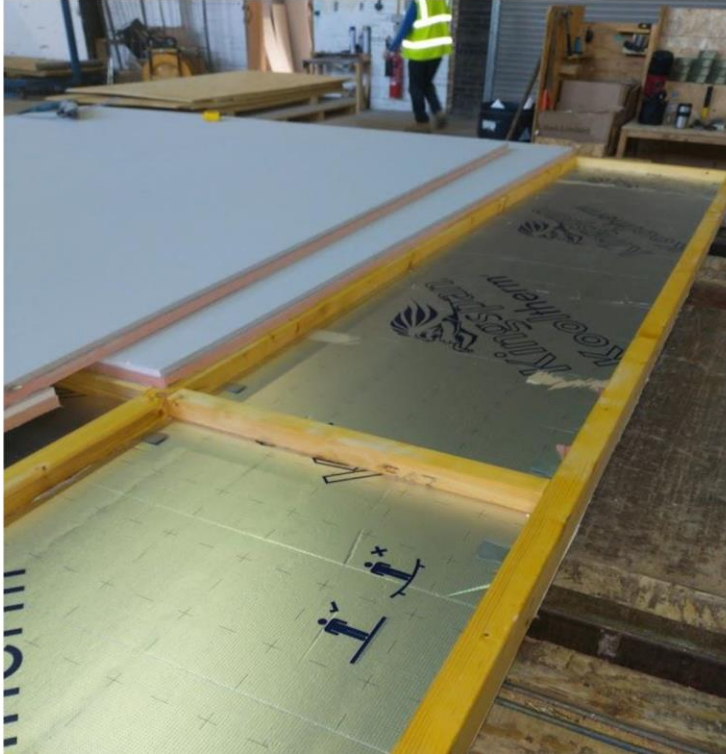
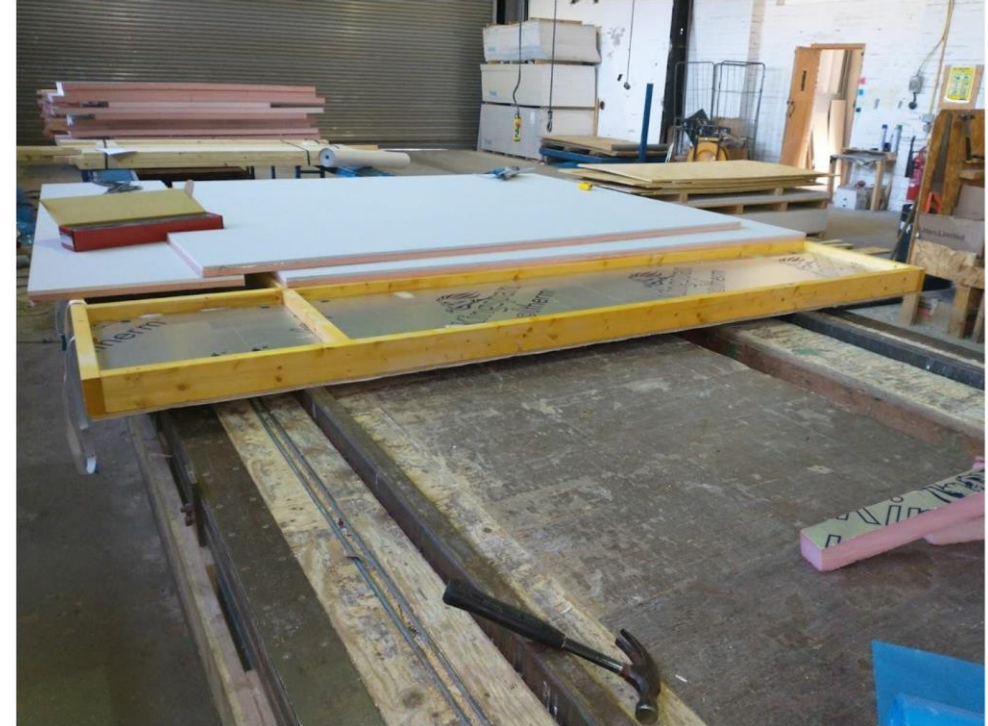
- K118 Insulated Plasterboard being fitted

Photograph 4 – View of the insulated plasterboard being fitted to the frame

A layer of Kooltherm K118 insulated plasterboard, 32.5mm thick (20mm insulation + 12.5mm plasterboard) was fixed the timber frame with 4.5x75mm (D x L), 45A75MP drywall screws (Durspin) at 300mm centres to all perimeter and intermediate timber. The plasterboard was taped and jointed using Gypsum tape and joint compound.

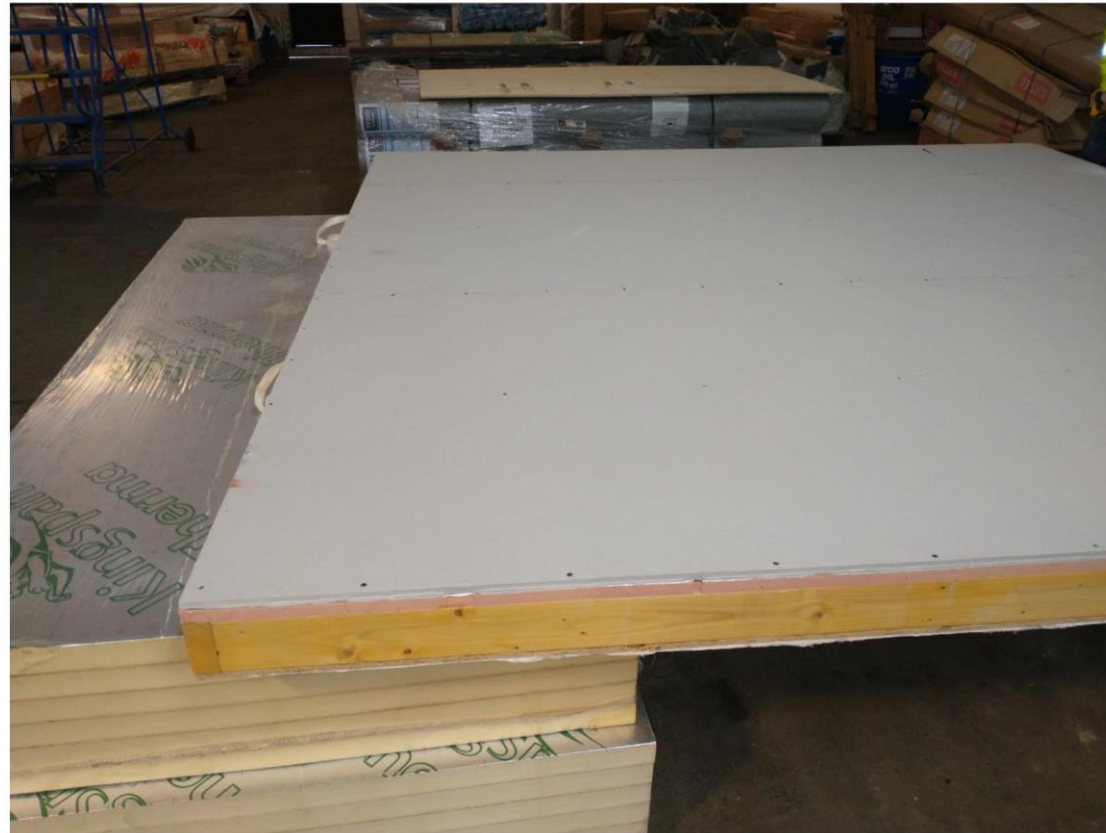
- Completed wall panel pre tape and joint

Photograph 5 – View of the completed sample, prior to applying tape and jointing compound

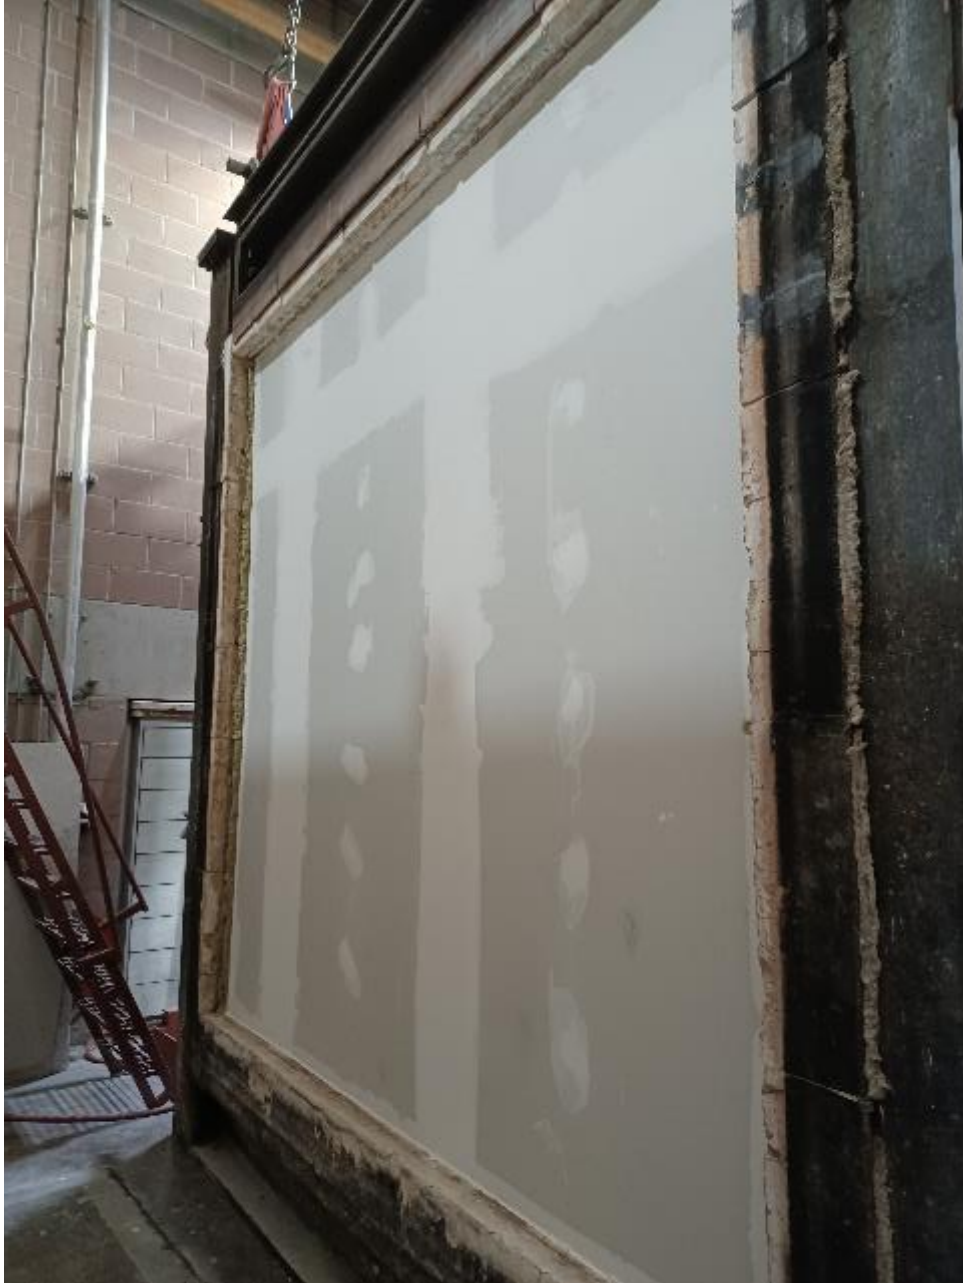
Photograph 6 – view of the exposed side of the sample prior to the test

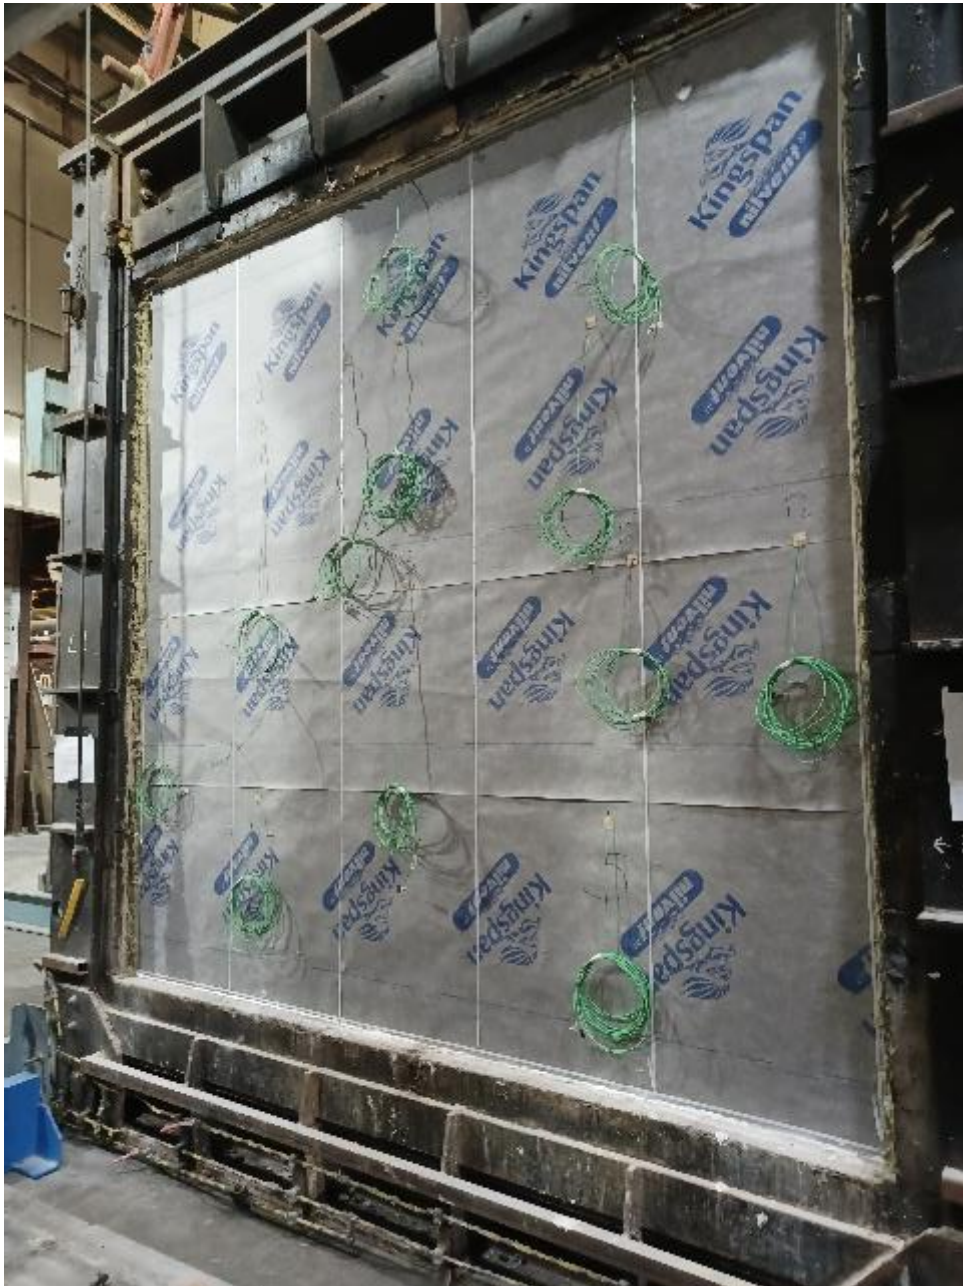
Photograph 7 – View of the unexposed side of the sample prior to the test

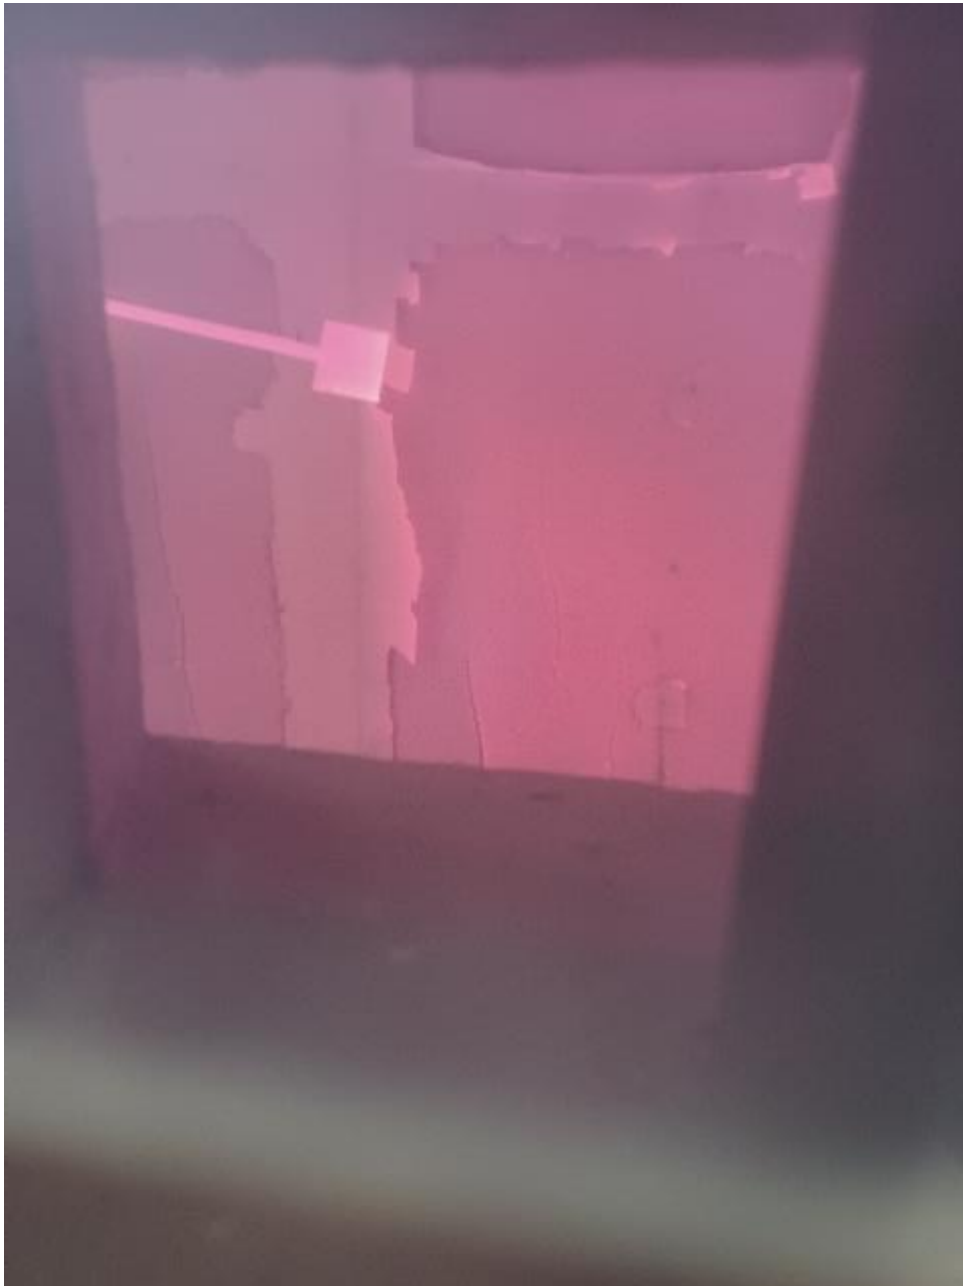
Photograph 8 - View of the exposed side at 11 minutes. Note the vertical cracks forming

Time (min)	Specimen	Observations
-15 :57	<b>Loading of the specimen</b>	
00	E/N	<b>Start of the test</b>
4	E	Slight glowing of the paper
7	E	Tape and joint burning off
10	E	Vertical cracks formed next to the left-hand side vertical joint
15	E/N	NSC
17	E	Flaming on the wall, vertical and horizontal cracks formed on the full-sized boards
22	E/N	Bubbling of the internal insulation
27	N	Smoke escaping near TC 9
30	E/N	NSC
37	N	Visible deflection
40	N	Holes forming in Nilvent layer
41	E/N	<b>Test stopped due to safety reasons</b>

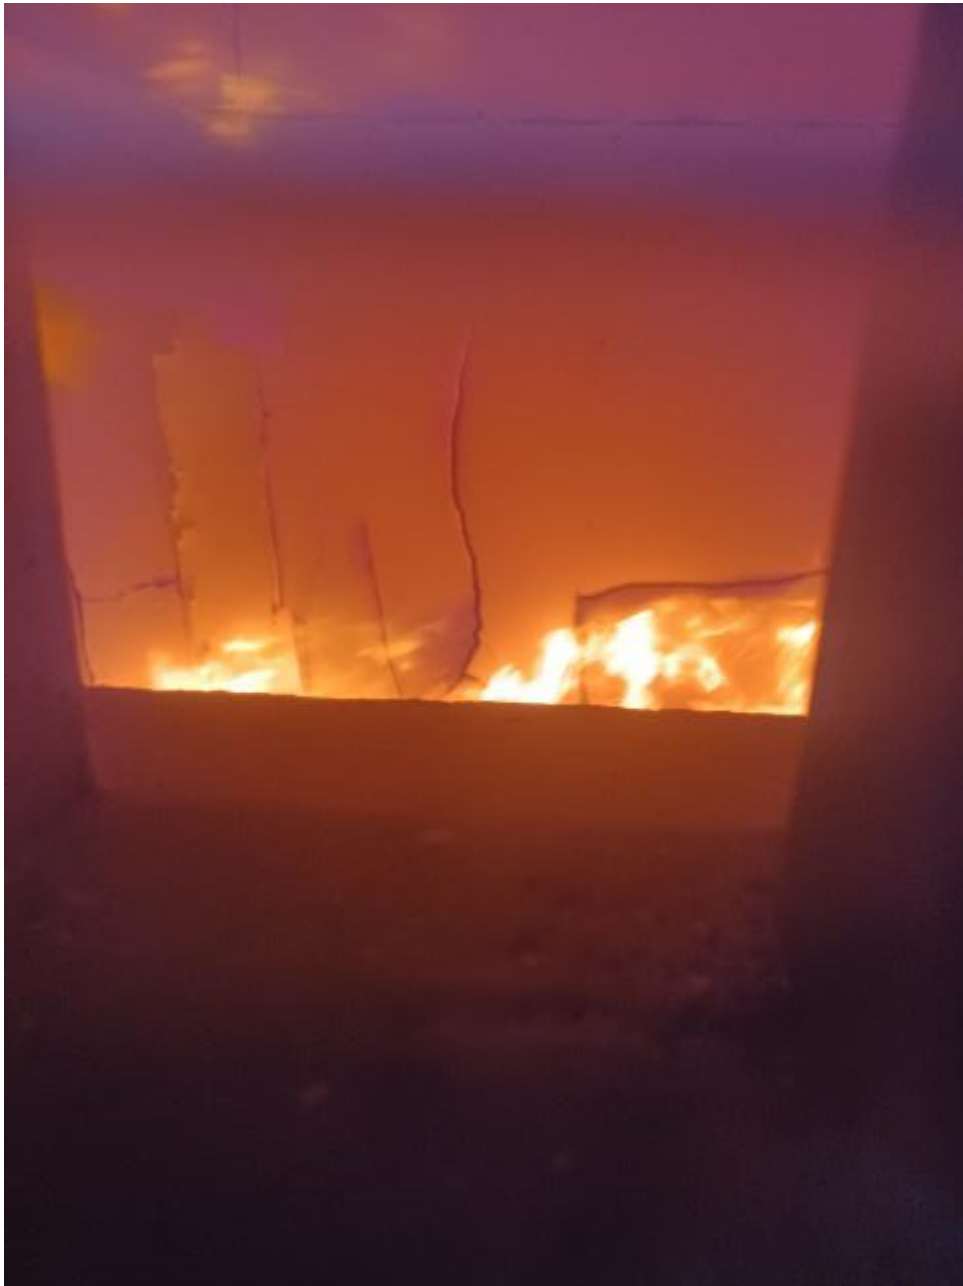
Photograph 9 - View of the exposed side at 17 minutes. Note the flaming and increased size of the cracks

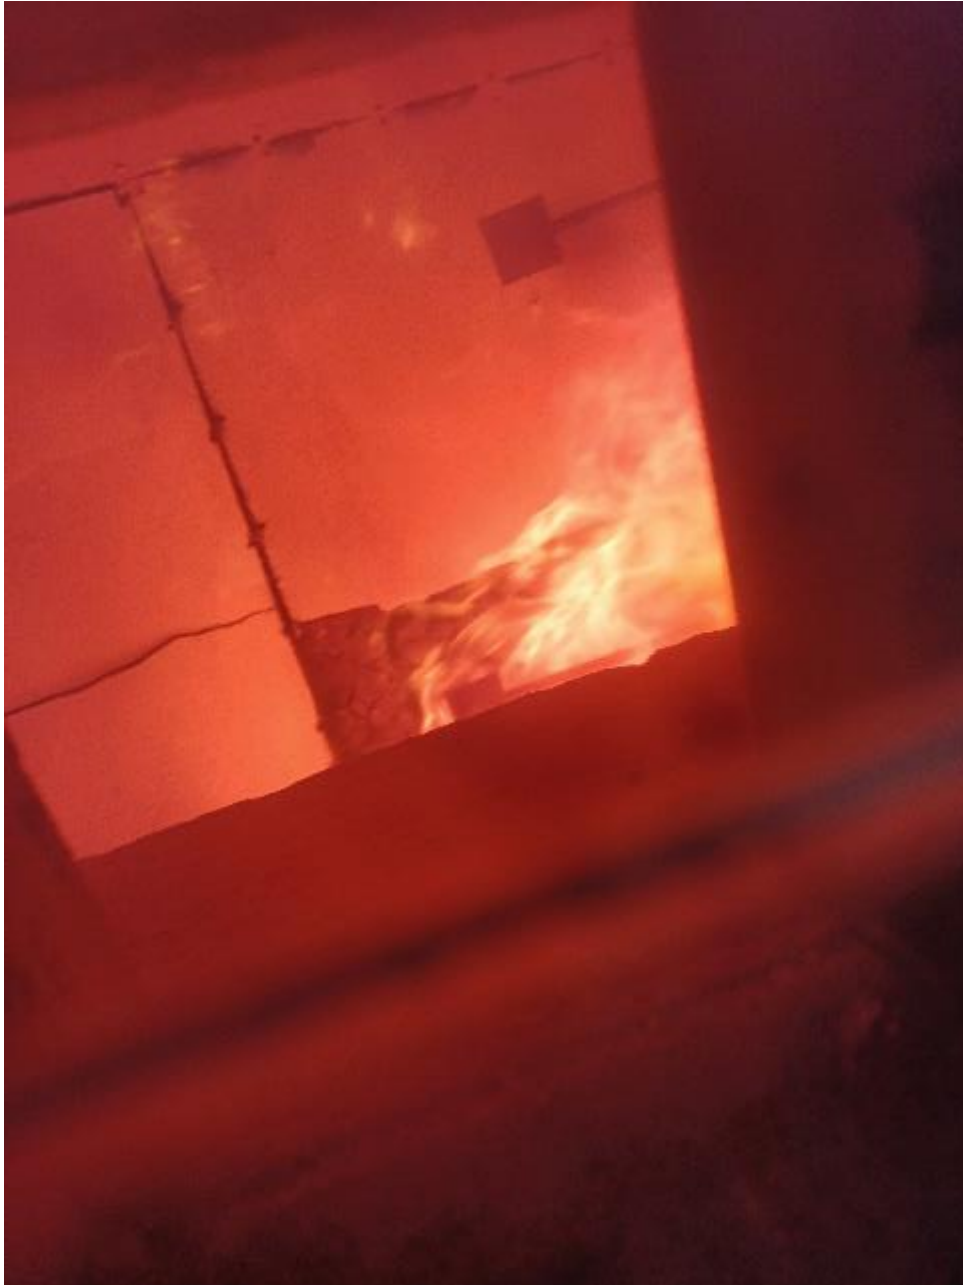
Photograph 10 - View of the sample at 19 minutes. Note the boards detaching

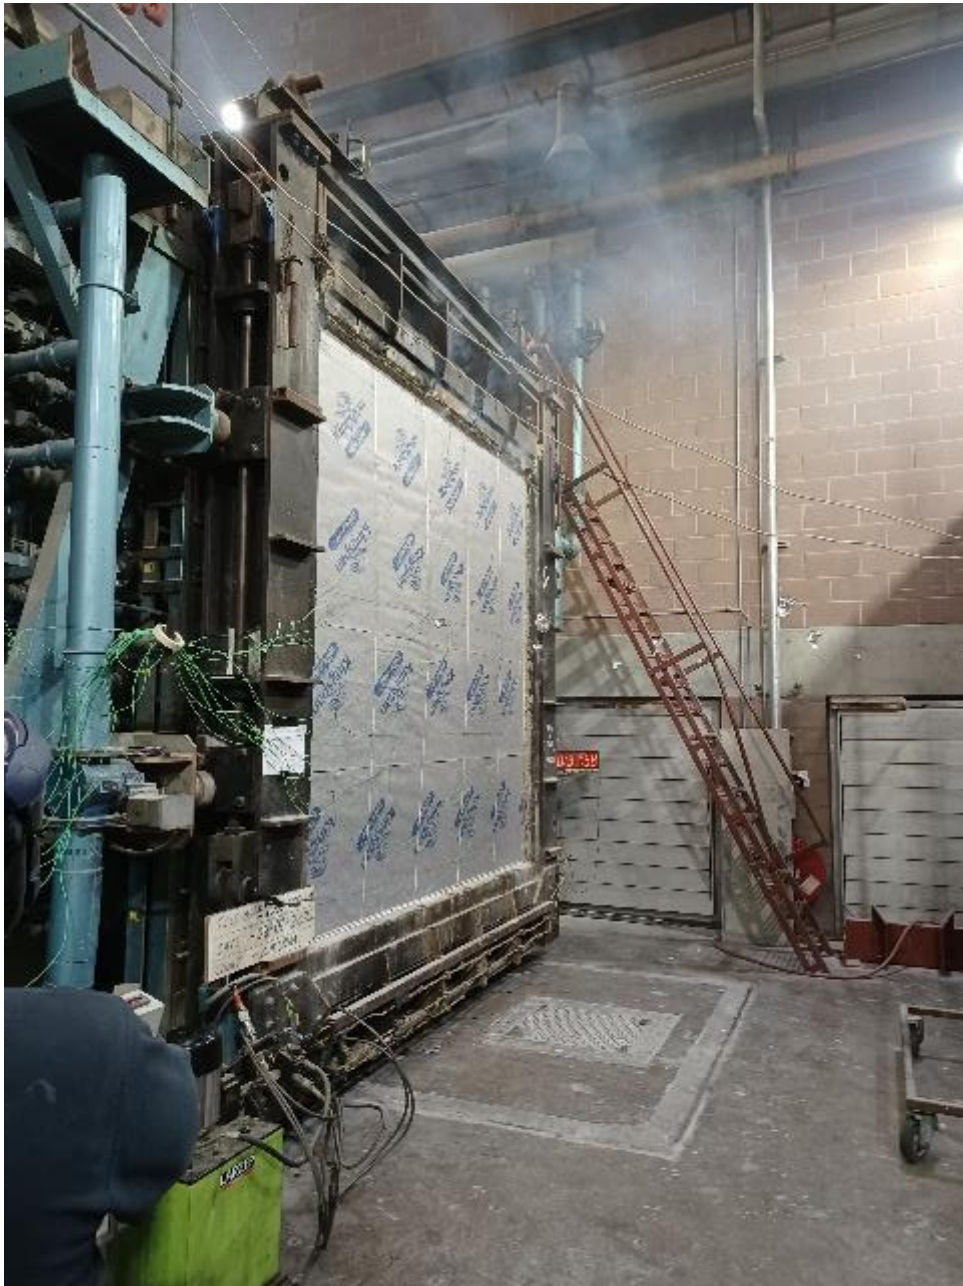
Photograph 11 - View of the unexposed side at 37 minutes. Note the visible deflection.

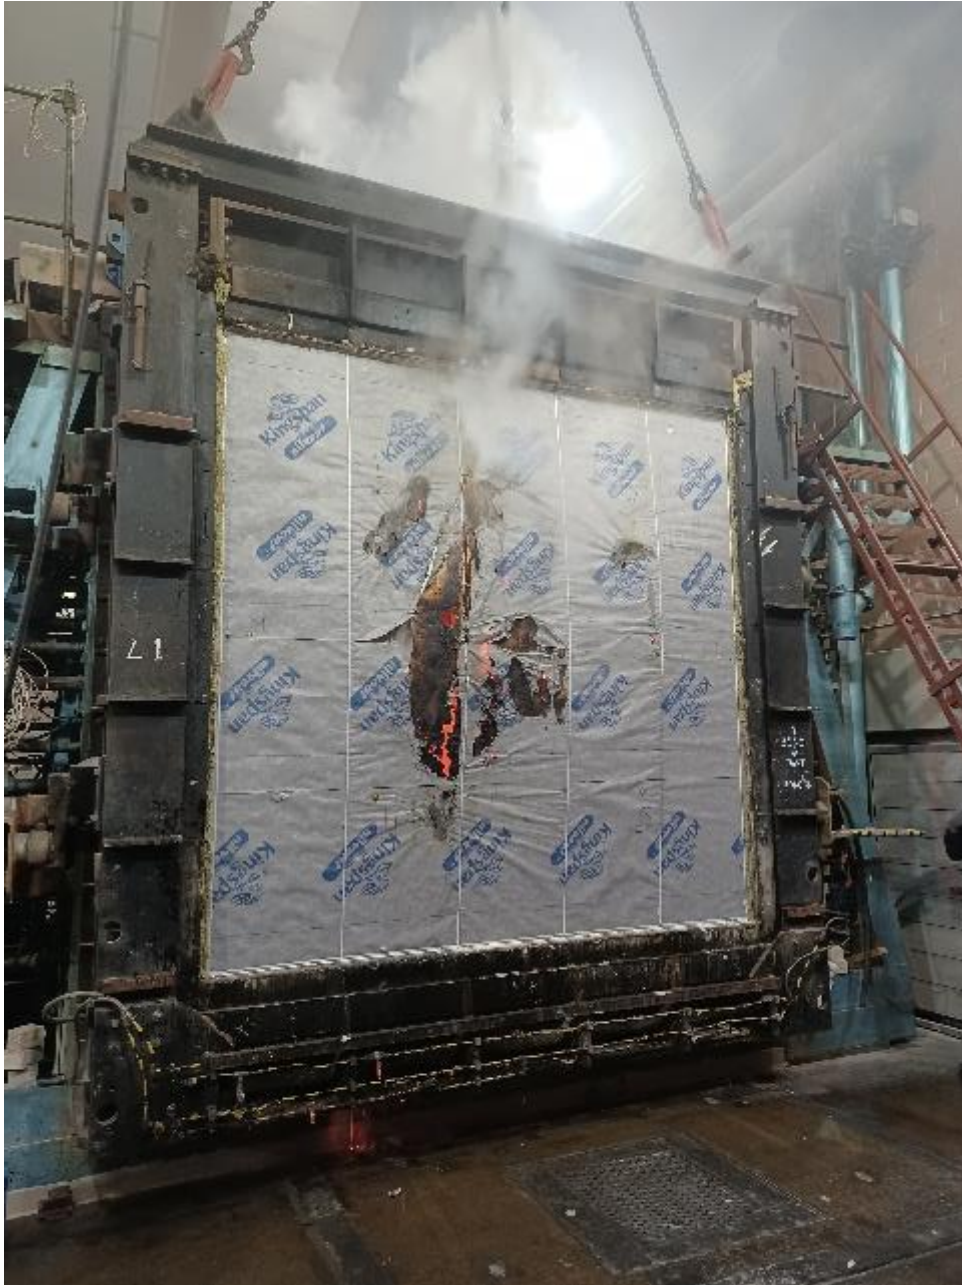
Photograph 12 - View of the unexposed side of the sample after the test.

See Photographs 12 and 13, Appendix D.

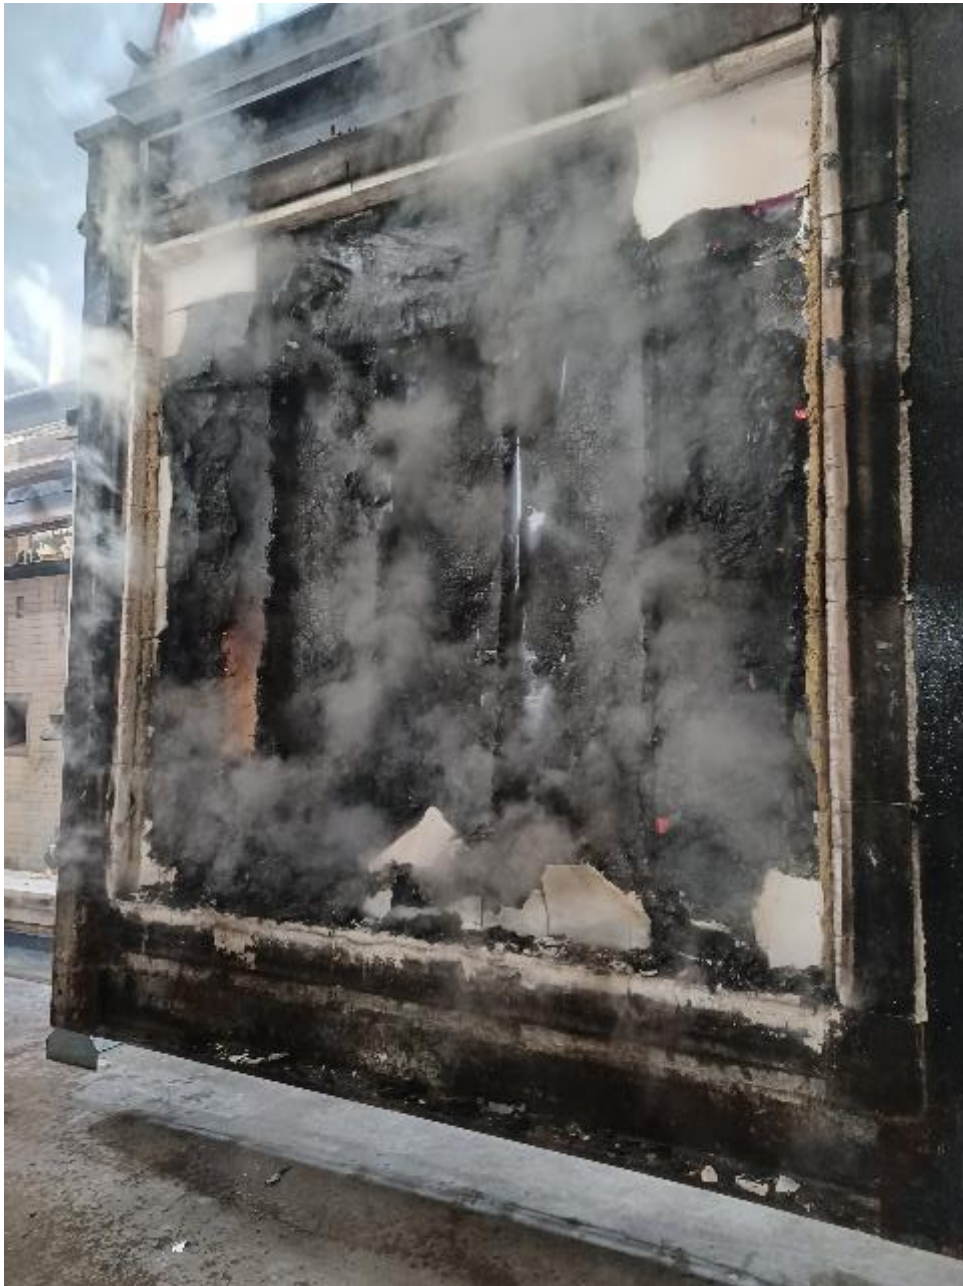
Photograph 13 - View of the exposed side of the sample after the test.
